| <b>solo®</b><br><b>AIRCRAFT ENGINES GMBH</b><br>Industriestrasse 9<br>D-71069 Sindelfingen | <b>Service Bulletin</b><br><b>E.237 – 3</b><br><b>Electric Propulsion system</b><br><b>8000 Series</b> | <b>EASA.AP.136</b><br><br>Seite 1 von 9 |

**Engine type:** Solo 8000 / 400 and Solo 8000 / 401

**Subject:** Propulsion reliability affected by EMI Problems, due to connection issues of grounding

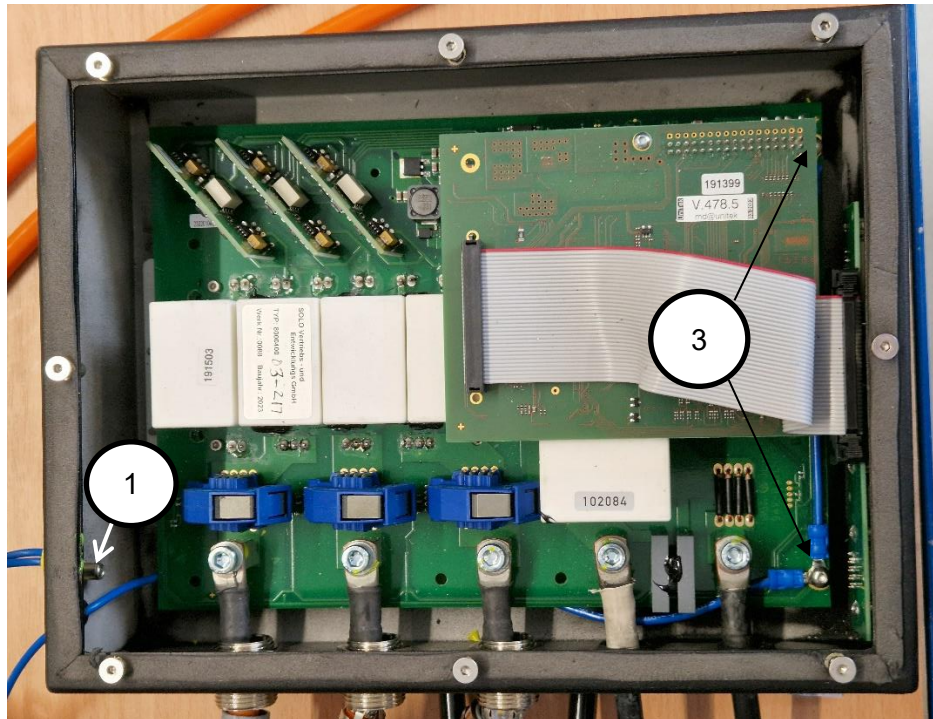
Fig. 1: Motor Controller

**Action 3:** Check for grounding at the resolver cable connector and the motor controller housing between Position 1 and Position 2.

If no grounding is detected, remove the hex stud, remove any kind of corrosion or painting underneath to ensure proper electrical contact.

- Action 4:** In case of a Motor Controller (MC) Power Fault, check the continuity between the screws at Position 3 in Figure 1: Motor Controller and Position 1. The resistance must be less than 0,2  $\Omega$ .

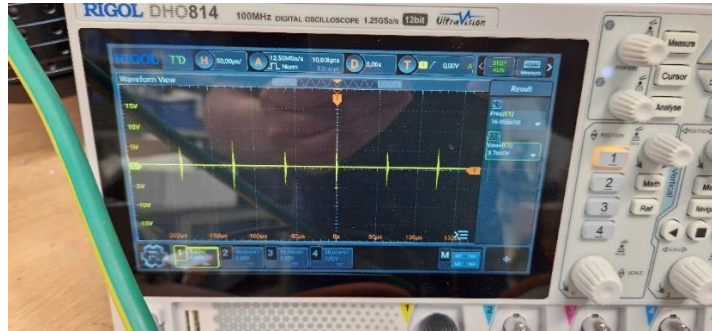
An acceptable result is the presence of a consistent less than +/-10 V peak-to-peak ripple (spike) at a frequency of approximately 16 kHz superimposed on the 12V DC line. This waveform is expected and aligns with the intentional design parameters of the system. Refer to Fig 4 and Fig 5. In case the specification can not be met, or any problems arise, Solo is to be contacted for verification.

Fig 4: EMI Spikes at the test bench

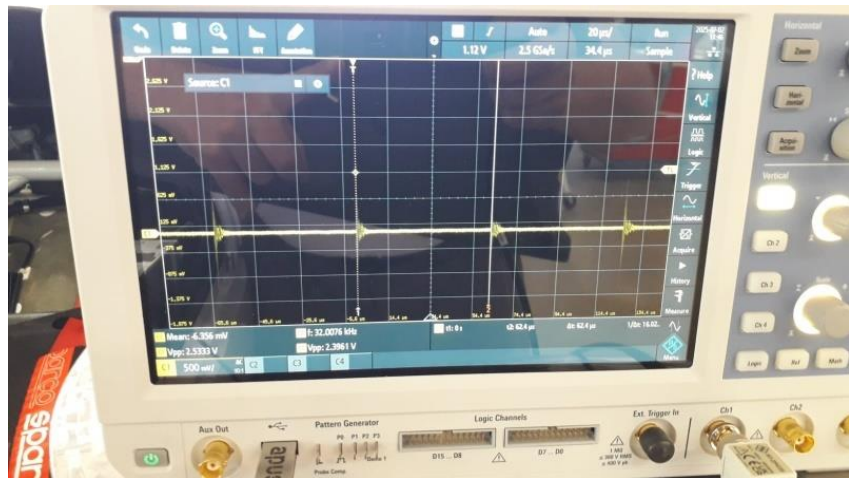
Fig 5: EMI Spikes at a reference glider

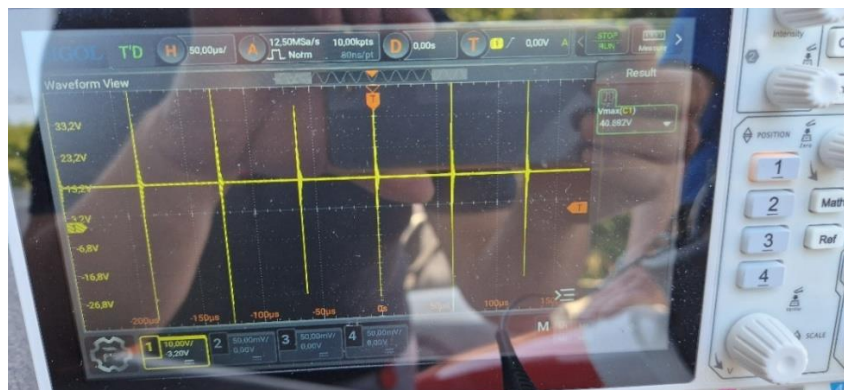
If voltage spikes exceeding  $\pm 10$  V are observed, refer to Fig 6, perform the following checks:

Fig 6: EMI spikes at the airframe out of tolerance

- Visually inspect the ground wire between the motor and the motor controller for mechanical damage, corrosion, or insulation degradation.
- Confirm that the installed wire size is min **AWG10**, if not, replace with cable of wire size min. AWG10.
- Resistance must be less than 100 mΩ measured at:
  - the motor controller housing to the cable end fitting
  - the motor to the cable end fitting
- Resistance must be less than 1Ω, measured between motor and motor controller housing

- Visually inspect the ground wire between the motor and the motor controller for mechanical damage, corrosion, or insulation degradation.
- Confirm that the installed wire size is min.**AWG10** are acceptable, if not, replace with cable of wire size min. AWG10.
- Resistance must be less than 100 mΩ measured at:
  - the motor controller housing to the cable end fitting
  - the airframe ground to the cable end fitting
- Resistance must be less than 1Ω, measured between motor controller and airframe ground
