| <b>solo</b><br><b>AIRCRAFT ENGINES GMBH</b><br>Industriestrasse 9<br>D-71069 Sindelfingen | <b>Service Bulletin</b><br><b>E.237 – 7</b><br><b>Electric Propulsion system</b><br><b>8000 Series</b> | Seite 1 von 3 |

**TCDS** EASA E.237

**Engine type:** Solo 8000 / 400

**Subject:** IMD replacement

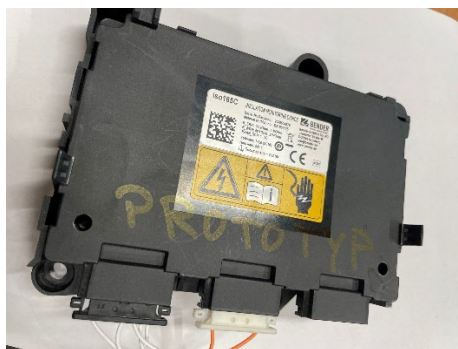
**Reason:** A new model of the Isolation Measuring Device is introduced with System SOLO 8000 / 401, which replaces the old one version in case of damage or a necessary repair.

Figure 1: old version

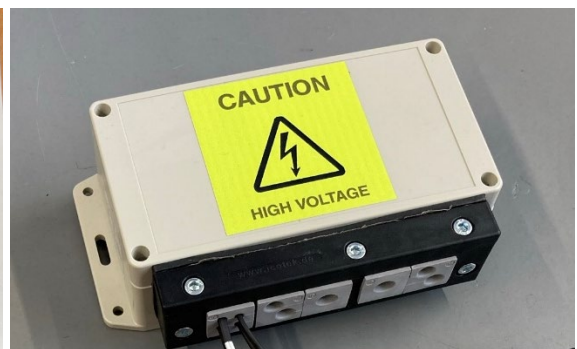
Both versions can be used together with the system SOLO 8000 / 400, the usage of the old version with SOLO 8000 / 401 is not possible.

Figure 2: new version

**Action 2:** The following instructions should be followed to change the IMD:

1. Request a new IMD from SOLO
2. Perform installation by replacing the current crimp contacts with new crimp contacts supplied by SOLO
3. Contact your aircraft dealer for spare parts for fixation of the device inside the airframe.
