| <b>solo</b><br><b>KLEINMOTOREN GMBH</b><br>Postfach 600152<br>D71050 Sindelfingen | <b>Service Bulletin</b><br><b>E.237 – 1</b><br><b>Electric Propulsion system</b><br><b>80400</b> | Seite 1 von 5 |

Engine type: Solo 80400

Subject: Update of the firmware of the DCU (Display and Control unit)  
Update of the firmware of the high voltage batteries

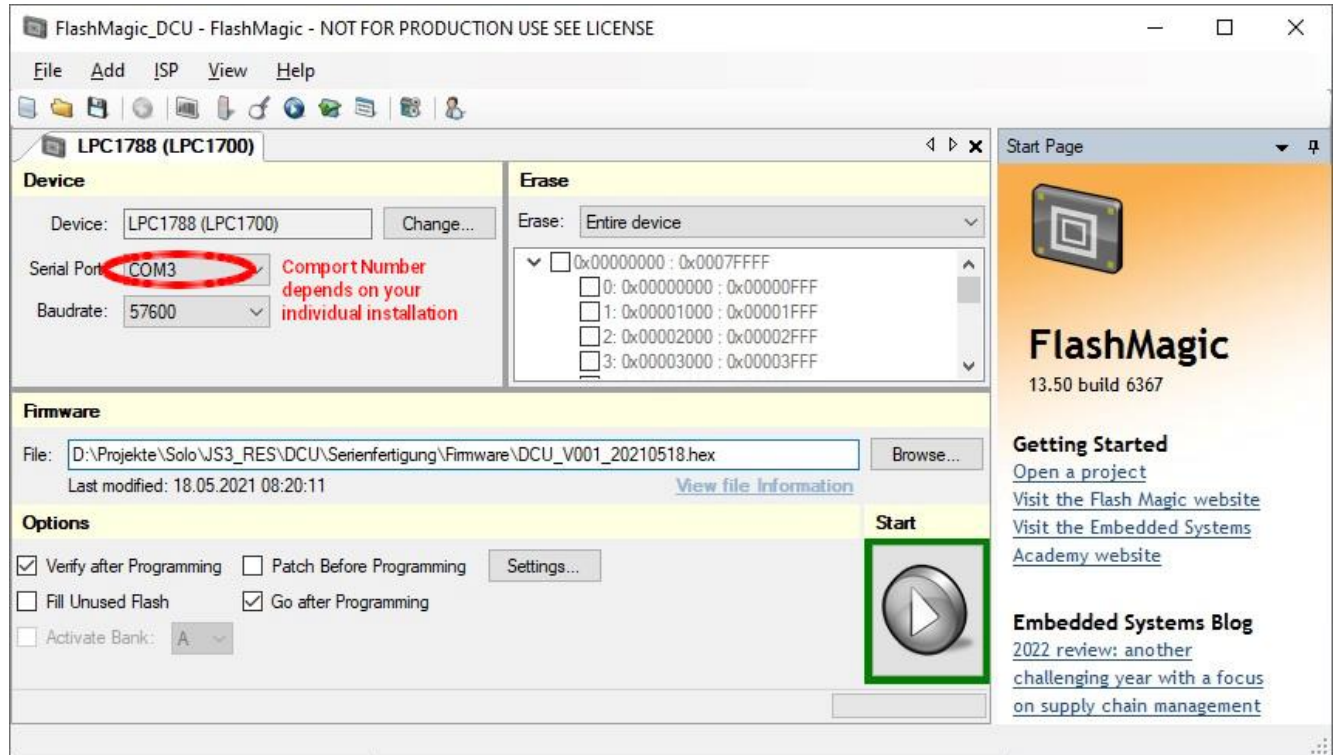
Turn propulsion main switch on.

Click the big button below Start to start the flashing process.
